Participatory Rural Appraisal for Diagnostic Analysis of spate irrigation systems in Raya Valley, Ethiopia

Abstract

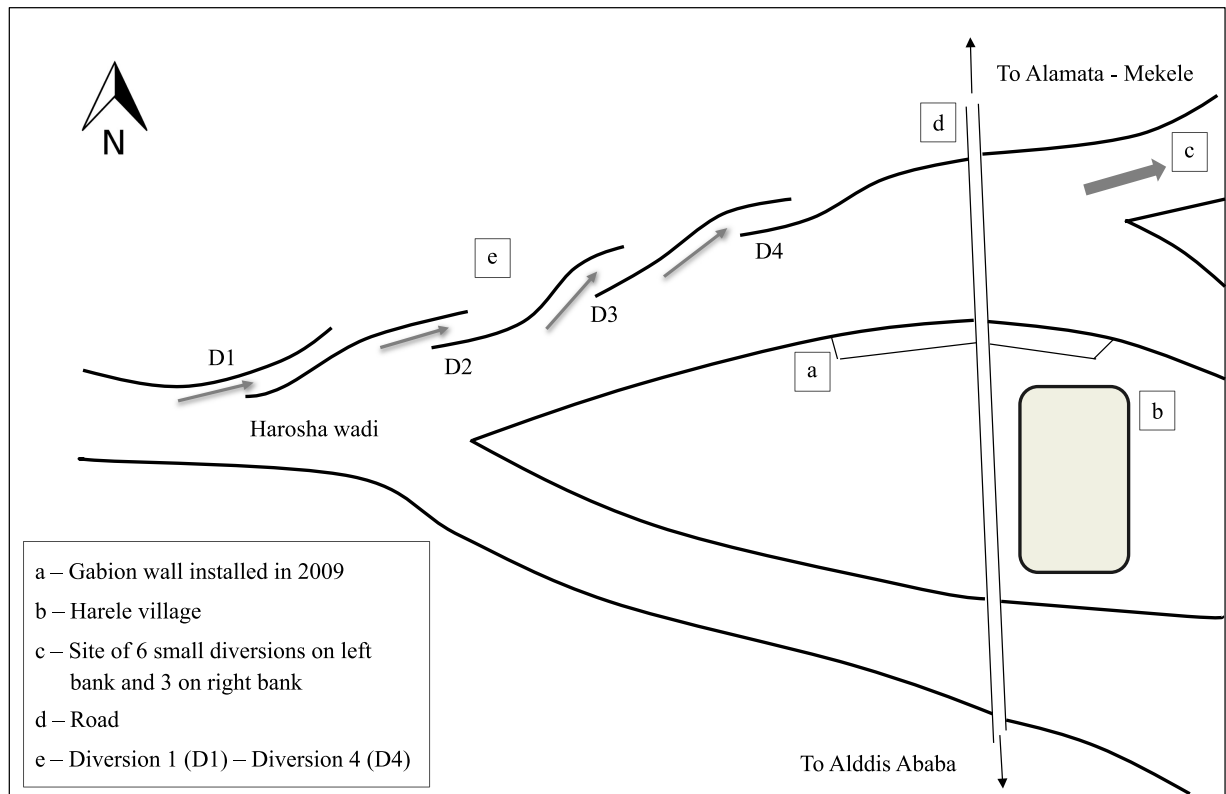
Fig. 2: Scheme of study area and diversion sites

of the 4 upstream diversions, identified as Diversion 1 (D1) to Diversion 4 (D4), starting from upstream. A scheme of the area is shown in Figure 2.

in which L_1 and L_2 are the width of northern and southern branches (Fig. 2).

In 2009, local government built a gabion wall for flood protection on the right side of the northern branch of the distributary system, in front of diversion structures sites (position “a” in Fig. 2). Gabion walls reduced the available section for water flows. As a result, the left bank of the channel collapsed, causing a reduction of cultivable lands. A loss of 13 ha in 3 years was reported. Farmers observed that protection walls should be built more distant from the wadi bed.

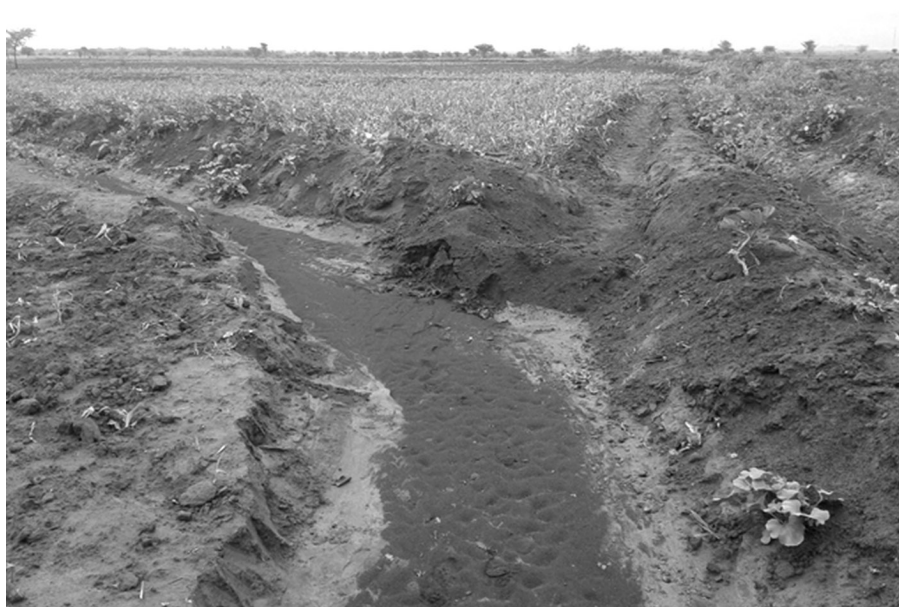
Fig. 4: Micro diversion bund at field level

Diversion structures in traditional spate systems are usually conceived as structures built with local materials like earth, stones and wood, in order to be easily repaired and adapted by the farmers to the morphodynamical evolution of the river. On the other hand, fixed concrete structures may result out of place from one to the next year, due to the continuous shifts of wadi beds (Van Steenberg *et al.*, 2010; Yazew *et al.*, 2014). Structure analysis and field walks revealed that diversion structures present in Harosha system area characterised by the typical “spur-type” design, as described by Van Steenberg *et al.* (2010), namely bunds, parallel to the flow, used for deviating a part of the discharge into a diversion canal.

The shape and the design of diversion structures are reported to be effective. In particular, the solution of using multiple diversions allow the farmer to be capable of irrigating a part of their land even if a diversion got broken, as they own land in more than one command area. Despite the advantages of traditional diversions, the main problem of diversion structures is that they are too often broken or washed away by flows.

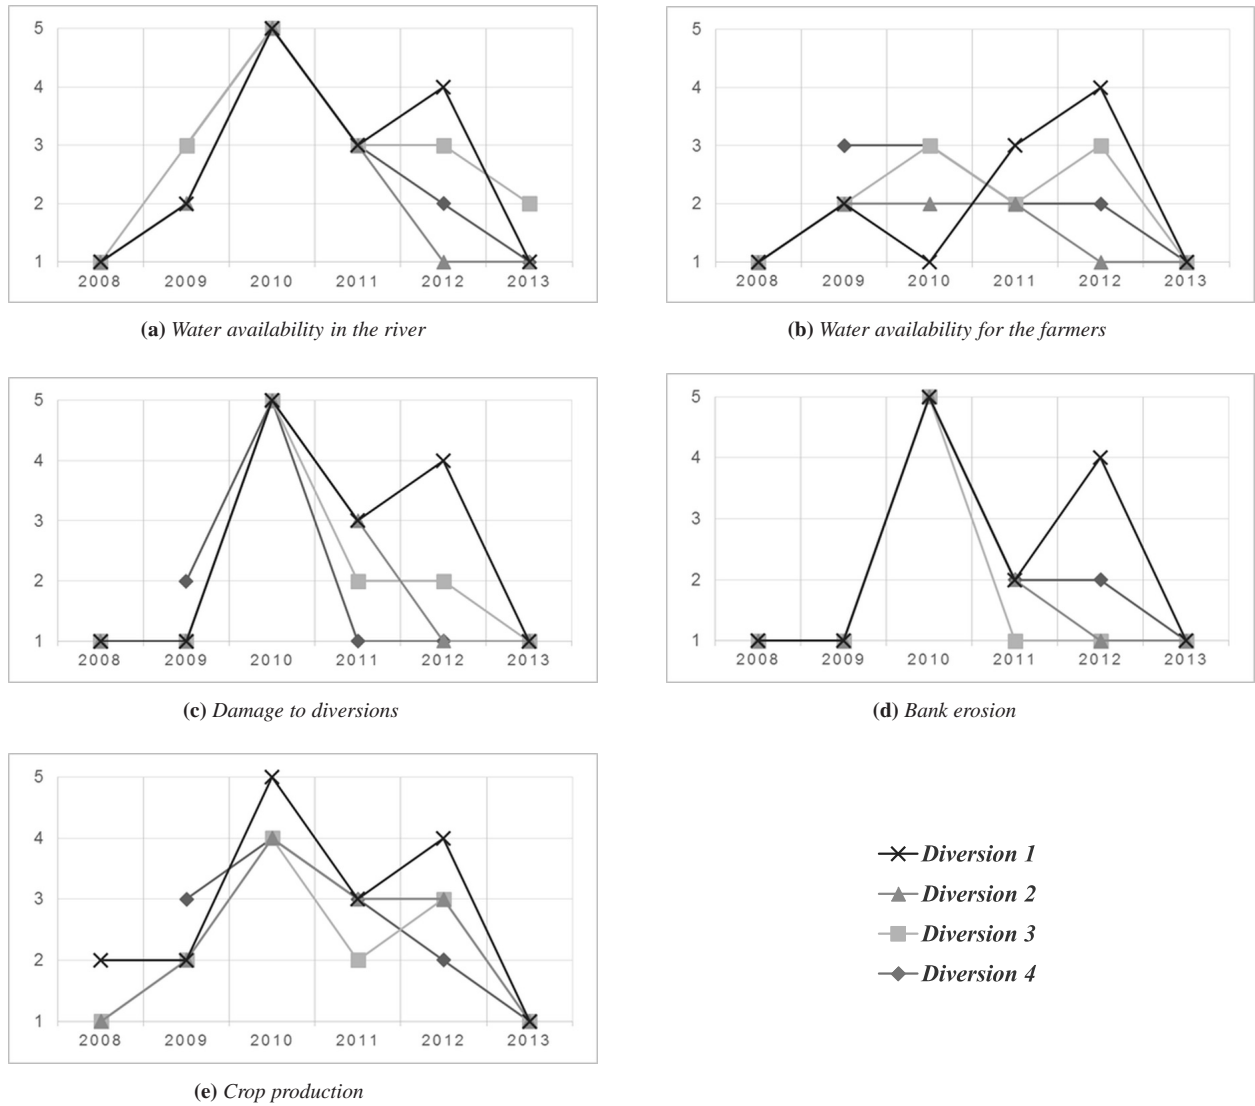
Fig. 5: Trend lines of the four diversions on a scale from 1 (low) to 5 (high)

Specific trend lines realised for each diversion (Fig. 5a to 5e) show that more water is available for D1 which is located upstream of the first subdivision of the river. This results also in higher water availability for farmers, leading to a better crop production, and higher erosion of the left bank. Trends 5b and 5d showed how D3 and D4 have been more resistant, leading to better water availability for farmers throughout the years.
